## **C-Coupon Studies of SiC/SiC Composites Part II: Microstructural Characterization**

Frances I. Hurwitz and Anthony M. Calomino  
NASA Glenn Research Center  
Cleveland OH, 44135

# **C-COUPON STUDIES OF SIC/SIC COMPOSITES**

## **PART II: MICROSTRUCTURAL CHARACTERIZATION**

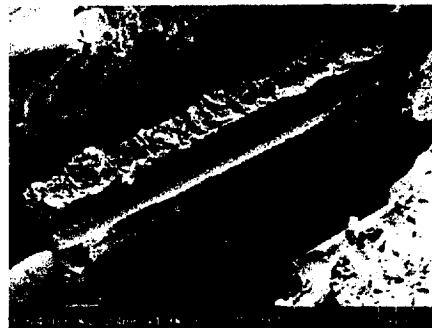
**Figure 7. Interphase failure in a Sylramic/S300 coupon tested at room temperature. Area shown is within a wider radial crack.**

the interphase region, as shown by the matrix "trough" where a fiber had been pulled away (Fig. 7). The orientation of the specimen prevented EDS analysis.

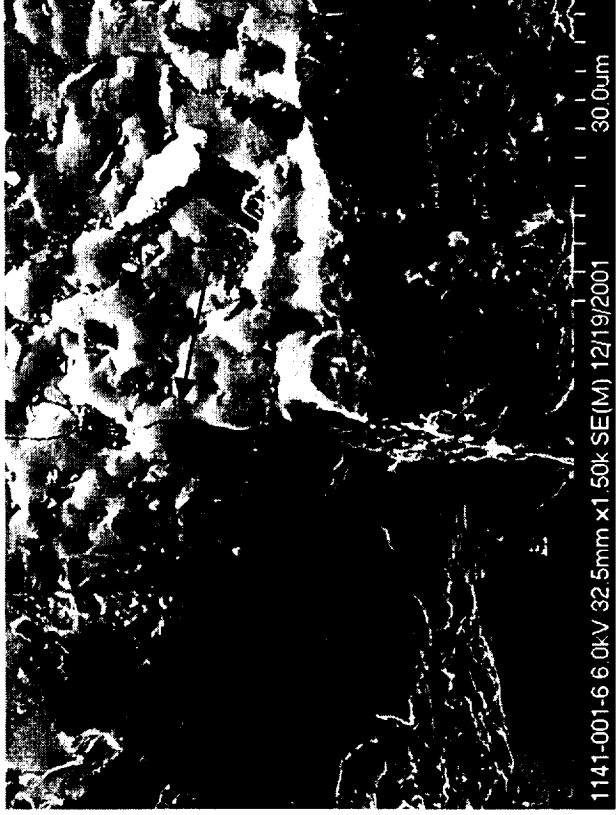
**ZMI/ MI ROOM TEMPERATURE, HOOP STRESS CRACK  
ON INNER RADIUS**

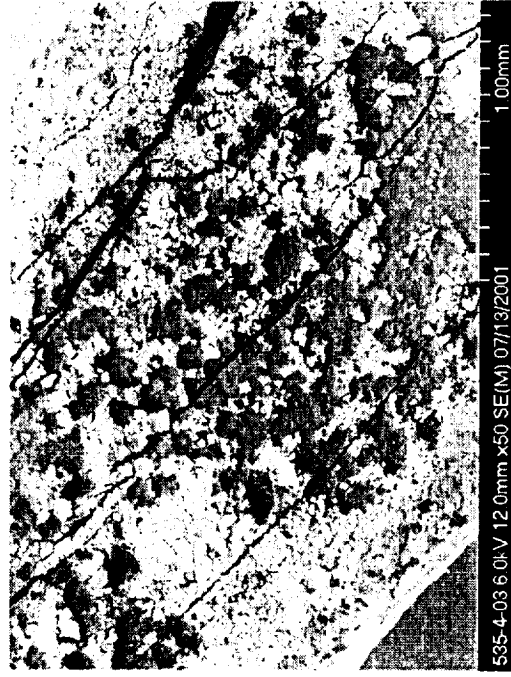
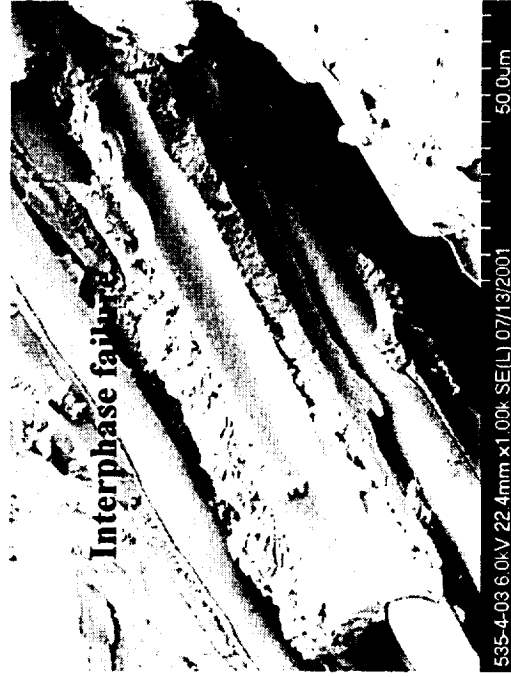
**SYLRAMIC/ S300**

**Room Temperature**

**816°C**
